AIR FORCE CIVIL ENGINEERING CENTER TYNDALL AFB FLA
PREMATURE FAILURE OF DEEP WELL ANODES.(U)
JUN 78 T F LEWICKI

CEEDO-TR-78-40

Premature Failure of Deep Well Anodes

FINAL REPORT FOR PERIOD
DECEMBER 1975-MAY 1978

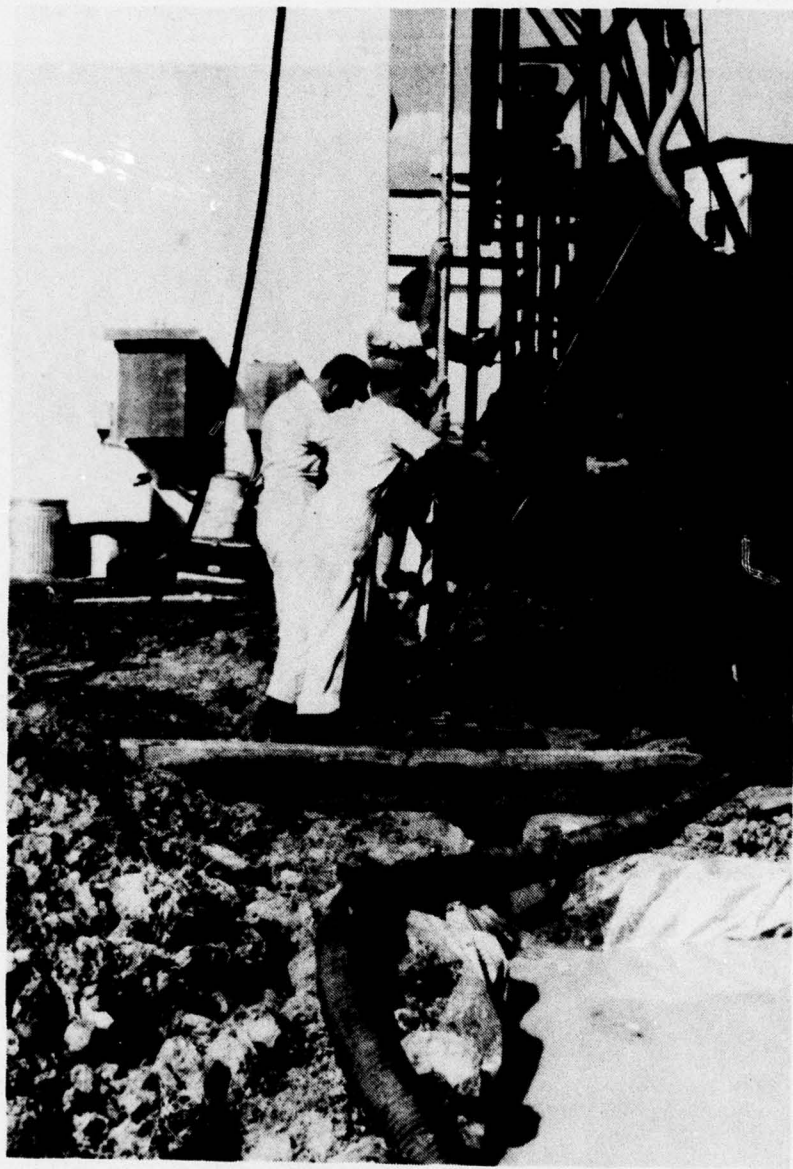
Figure 1. Fluidizing Clay in the Well

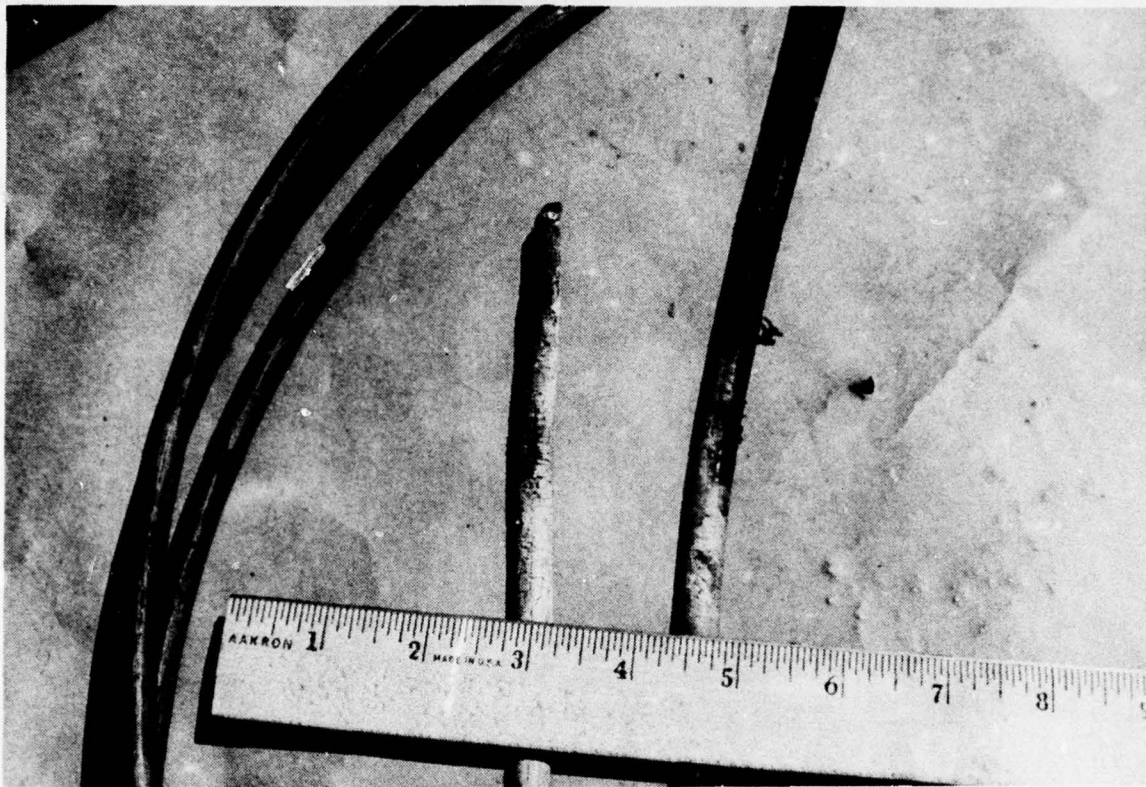
A military team from the field activities branch of the Civil Engineering Center arrived at Barksdale AFB LA on 16 June 1976 for the purpose of retrieving failed anodes and lead wire from a 250 foot deep well. The well contained 12 anodes spaced as shown in Table 1. The three foot diameter steel plate welded to a short piece of 8" casing that served as the well cap was removed. No gravel was found in the top of the well. Eight feet below ground level the well was filled with what appeared to be the original red clay. The clay in the well was fluidized by pumping drilling mud down the hole through 1-1/2 inch pipe fitted with a special point. The point had two holes drilled into it at a 45° angle so as to make the high pressure drilling mud effective in fluidizing and enlarging the backfilled hole. Working the 1-1/2 inch mud pipe into the hole went fairly easily. A total of 147 feet was fluidized during the first day (See Figure 1). Progress through the coke breeze was much slower. The mud viscosity was 48. At the end of the second day of work, the bottom of the well was reached (251 ft). We tried pulling the anode lead wires as a bundle and individually but none of the anodes would move. During the third and fourth days, we pumped mud at high pressure (400 to 500 PSI) while working the 1-1/2 inch mud pipe up and down the well. We also introduced blasts of air from a large compressor (115 PSI) down the hole through the mud pipe. Finally, with nothing left to do, we pulled the wires. All wires broke at various depths. Wire No. 1 broke 15 feet from the surface. Examination showed that the insulation had been damaged and the copper conductor had corroded in two. Wire No. 3 had been burned by the torch of the welder who cut open the well cover. Several of the wires had been damaged by the 1-1-1/2 inch mud pipe. The length of wire No. 4 retrieved was 216 ft. This means that it separated near the top of anode No. 4. The bottom end of this wire showed complete deterioration of the high molecular weight polyethylene insulation. The insulation turned white in certain areas, cracked and necked down until the copper was exposed and corroded to failure (Figure No. 2). Figure 3 shows the deteriorated insulation magnified by 10. It is obvious from the examination of the deteriorated insulation of Wire No. 4 that No. 4 anode failed because the copper conductor corroded in two after the insulation deteriorated. It is reasonable to assume that the other seven inoperative anodes failed either from mechanical damage to the lead wire insulation or from deteriorated insulation.

Figure 2. Deterioration of Insulation on Wire No. 4

1. Where chlorides are present, HALAR[®] insulated wire with a HMPE jacket for mechanical protection should be used in place of all HMPE insulation.

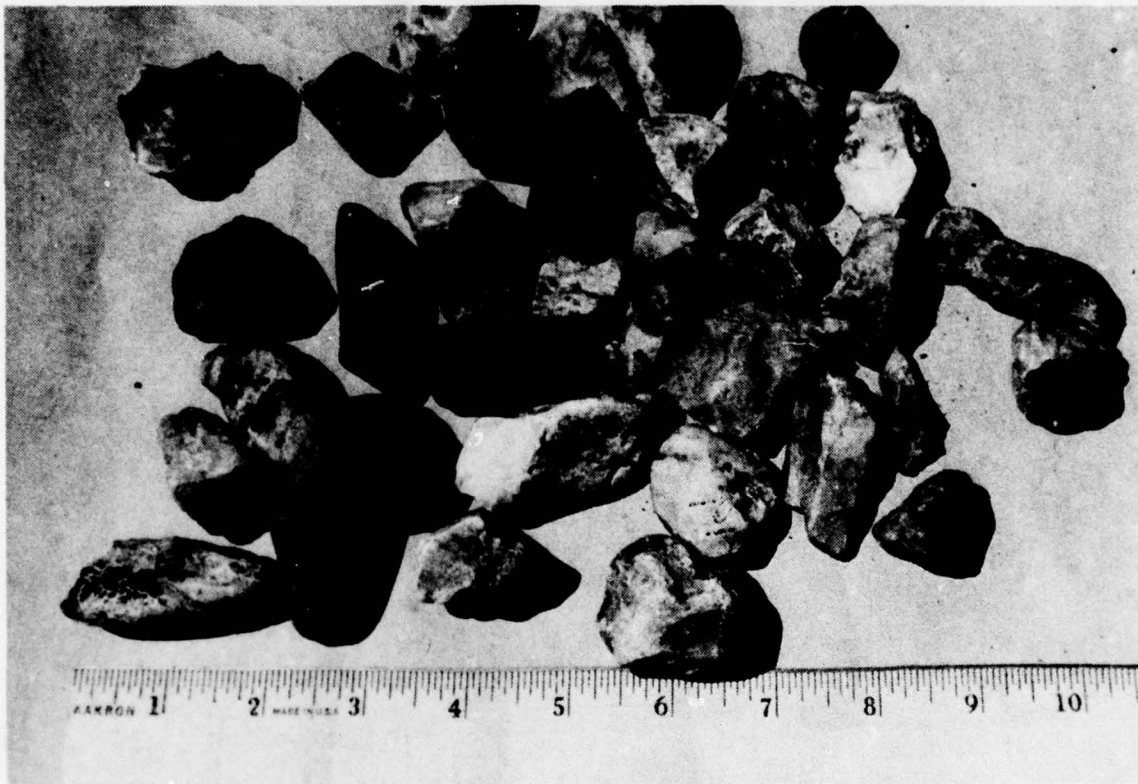
The well drilling machine was set up over the well and an effort was made to fluidize the backfill in the well similar to what was done at Barksdale AFB. Mud viscosity had to be increased above 500 in order to float out the large gravel. Pump pressure was raised as high as 500 to 550 psi. The entire column of 40 ft of large gravel was successfully removed by fluidizing with thick mud. Gravel as large as 2 inch diameter (Figure 4) was floated to the surface. After the fluidizing pipe reached the 80 ft level, 5 anodes were easily removed. Two of the five anodes had broken approximately 1/4 of the way from their bottom end (Figure 5); the other three anodes appeared to be in like new condition.

Figure 4. Large-diameter Gravel Floated Out of Well

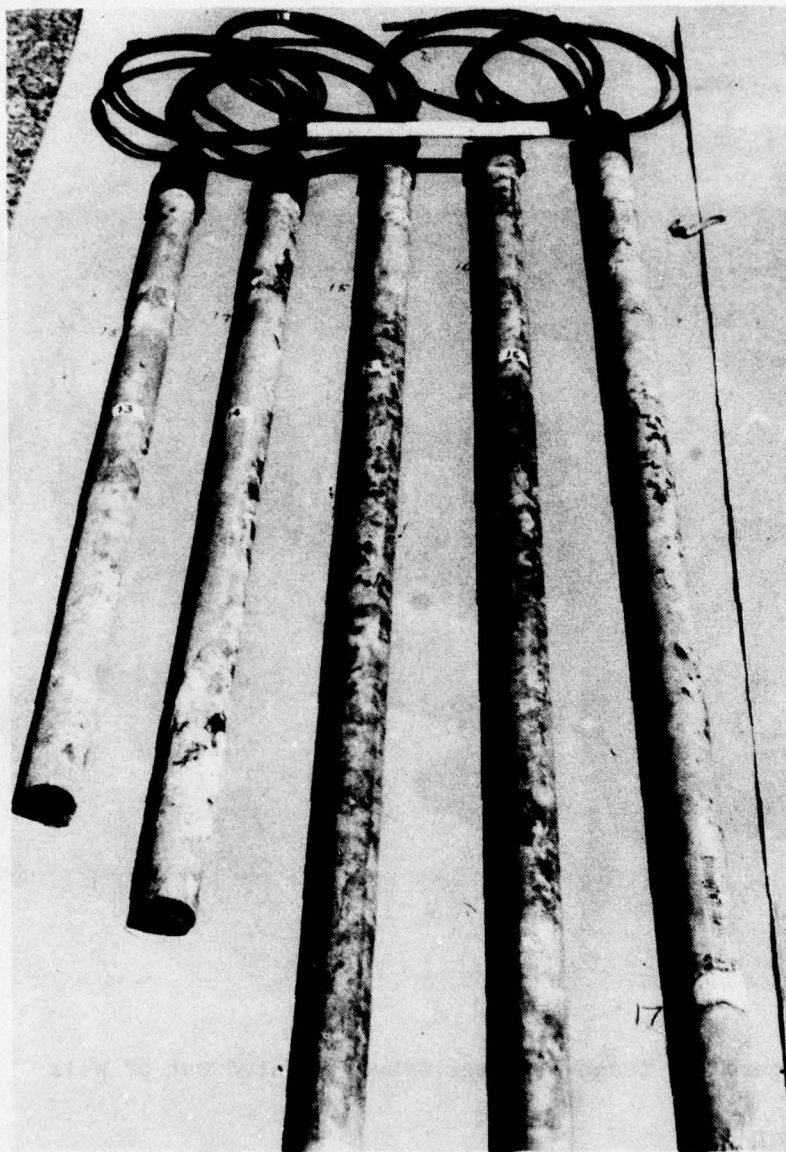
Figure 5. Anodes Taken From Well

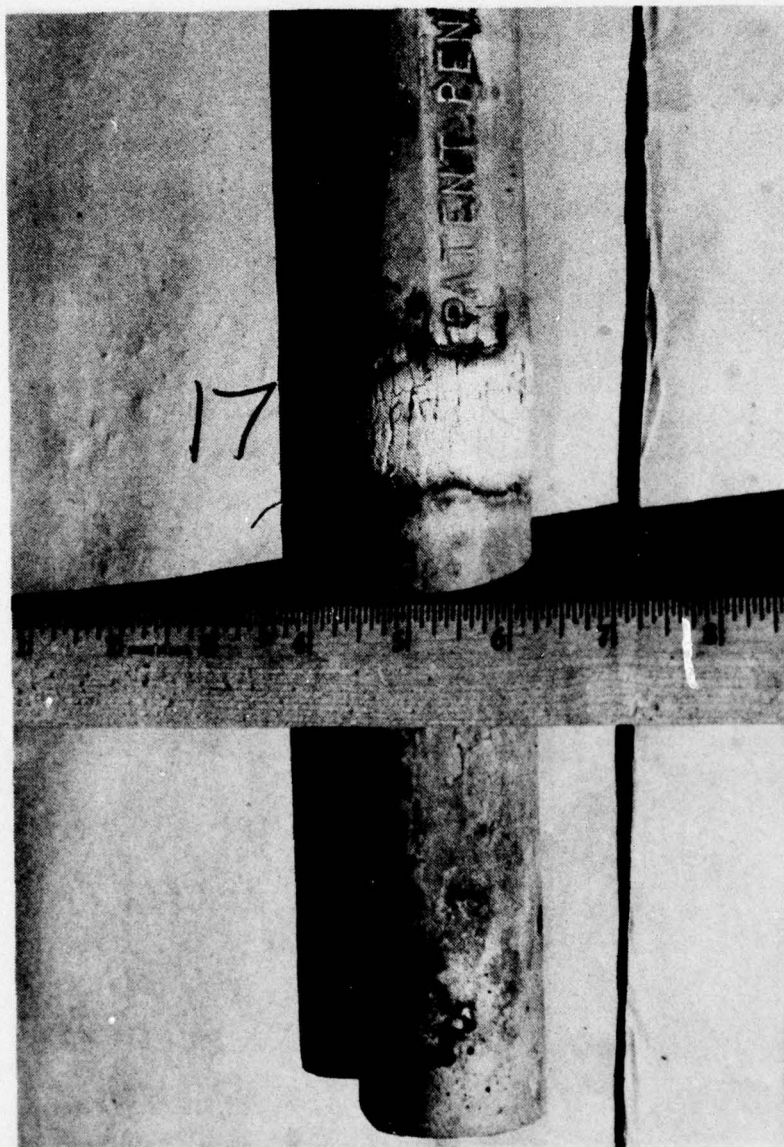
It has been suggested that the film of silica (SiO_2) that always develops on the outside of a HSCI anode can, under certain conditions, become a high resistance film. There was no evidence of this in this case. As soon as the anodes were extracted they were carefully examined. Visual examinations showed no visible oxide film. An electrical continuity test between the top end of the lead wire and the anode body showed almost zero resistance. When the anodes were placed in a water filled tub in the laboratory with a small voltage applied, current output was high, indicating low resistance between the anode and the water. Resistivity of the water in the lab test was 6800 ohm-cm whereas the resistivity of the water in the well at Little Rock is 6200 ohm-cm. It is the author's opinion that the only cause for such low current output was gas blockage between the anode and the coke breeze. Figures 6 and 7 show sections of the anodes where the worst corrosion damage occurred.

Figure 6. Corrosion Damage

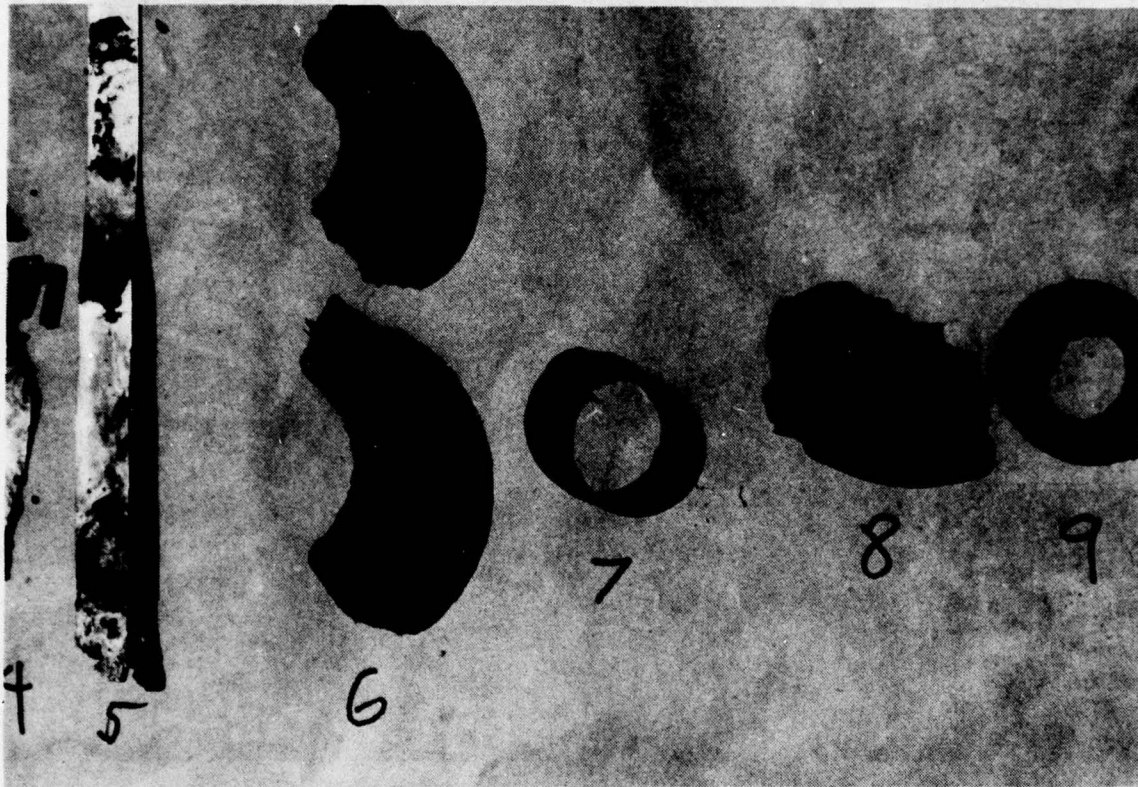
Figure 8. Items Retrieved From Anode Bed

a. In Figure 8 from left to right, stainless steel bands that held anodes to support pipe, wooden spacers that were placed around anodes, plastic insert from insulated union (7), parts of an insulated union with most of the steel corroded away (8 and 9). These parts were designed to hold the anodes only until the backfill was in place and their deterioration is to be expected.

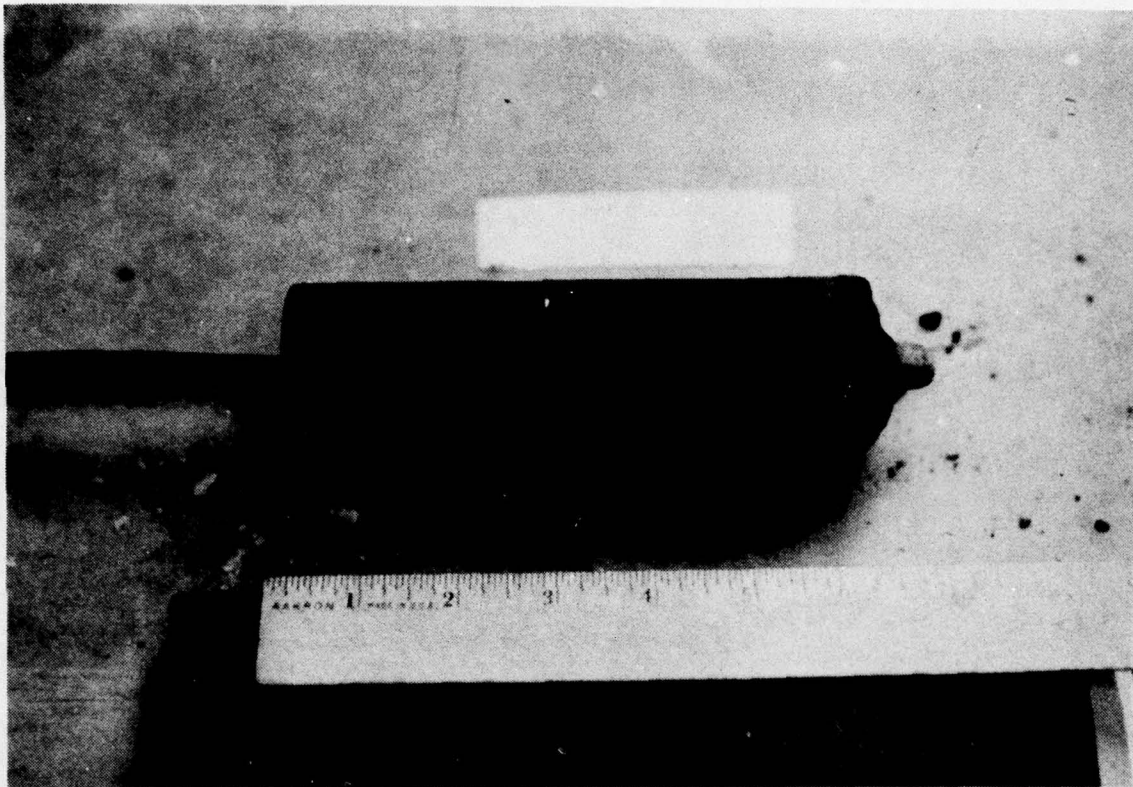
b. The high silicon cast iron anodes suffered less weight loss and corrosion damage than the graphite anodes. Condition of anodes after test can be seen in Figure 16 through 19. Figures 16 through 18 show the condition of graphite anodes, whereas Figure 19 shows the condition of the high silicon cast iron anodes.

Figure 17. Corrosion Damage to Graphite Anode, Drum 2

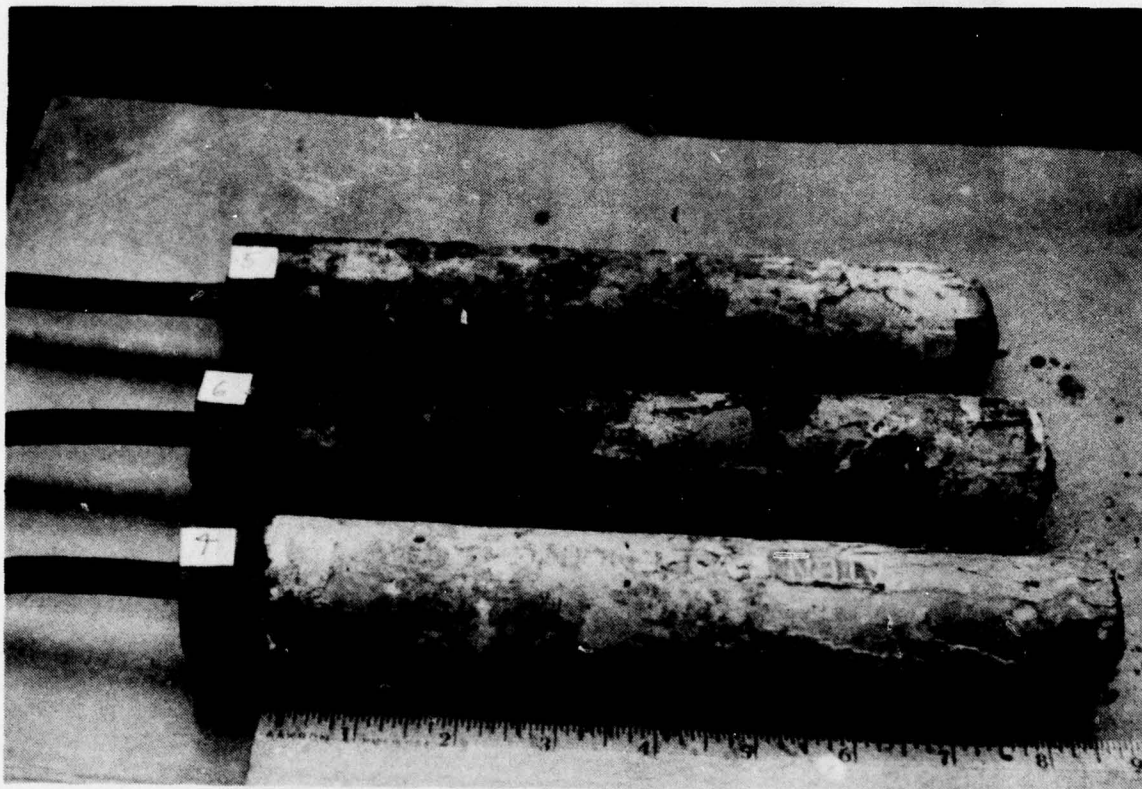
Figure 19. Corrosion Damage to High Silicon Cast Iron Anodes
